**POHATCONG LAKE**

**DAM LEVEL II**  
**NJ 00504**

**PHASE 1 INSPECTION REPORT  
NATIONAL DAM SAFETY PROGRAM**

**MARCH 1980**

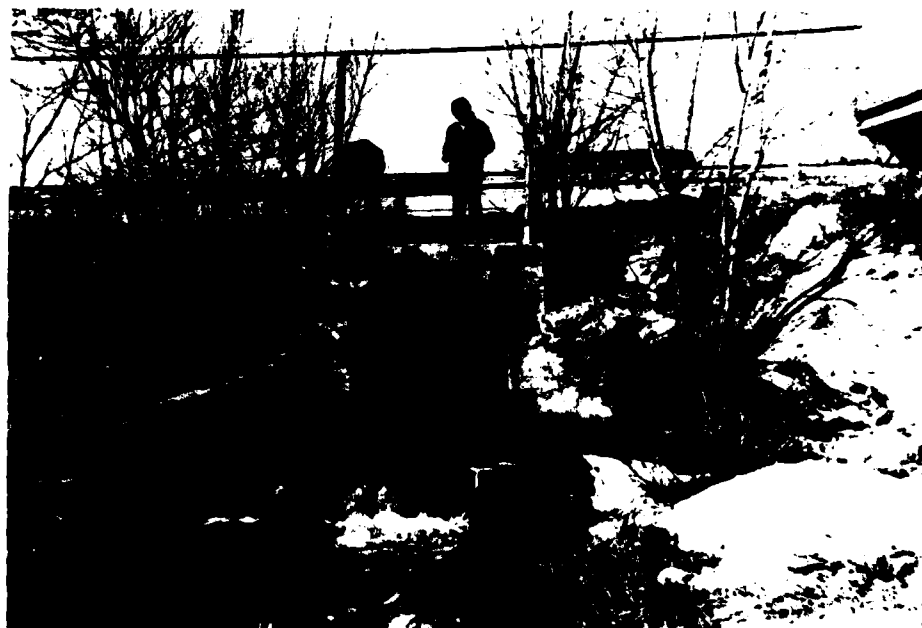
November, 1979  
View of Main Spillway Outlet

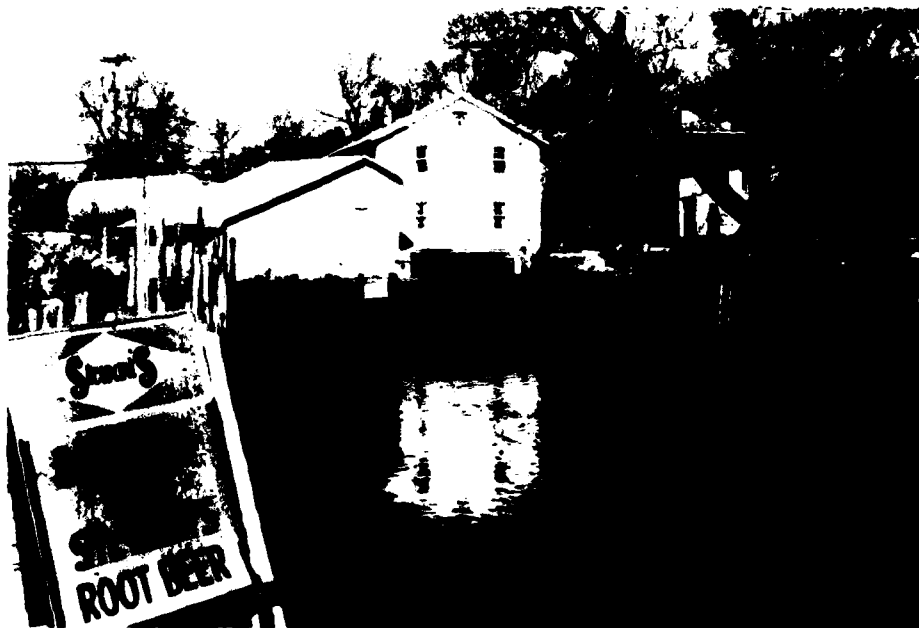
View of Auxiliary Spillway Outlet (Penstock Through Utility Building)
